Contract #: 04-0120F4Cty: SF/ALA Rte: 80 PM: 13.2/13.9File #: 74.28**WELDING INSPECTION REPORT****Resident Engineer:** Casey, William**Address:** 333 Burma Road**City:** Oakland, CA 94607**Report No:** WIR-028721**Date Inspected:** 07-Nov-2012**Project Name:** SAS Superstructure**OSM Arrival Time:** 530**Prime Contractor:** American Bridge/Fluor Enterprises, a JV**OSM Departure Time:** 1600**Contractor:** Goodwin Steel, UK**Location:** Stoke-On-Trent, UK**CWI Name:****CWI Present:****Yes No****Inspected CWI report:** Yes No N/A**Rod Oven in Use:** Yes No N/A**Electrode to specification:** Yes No N/A**Weld Procedures Followed:** Yes No N/A**Qualified Welders:** Yes No N/A**Verified Joint Fit-up:** Yes No N/A**Approved Drawings:** Yes No N/A**Approved WPS:** Yes No N/A**Delayed / Cancelled:** Yes No N/A**Bridge No:** 34-0006**Component:** Type B16 Supplemental Cable Bands after proof**Summary of Items Observed:**

## WELDING INSPECTION REPORT

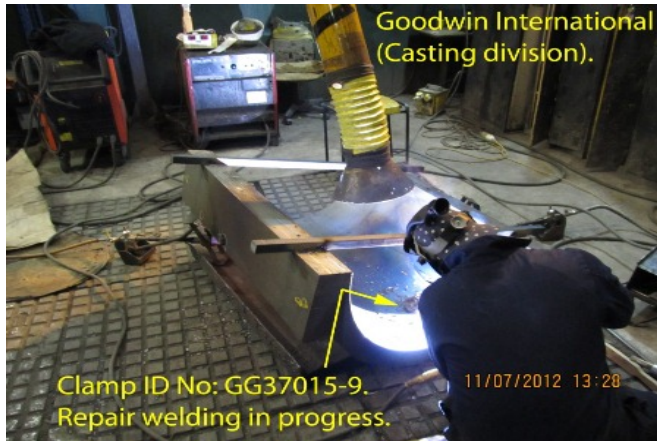
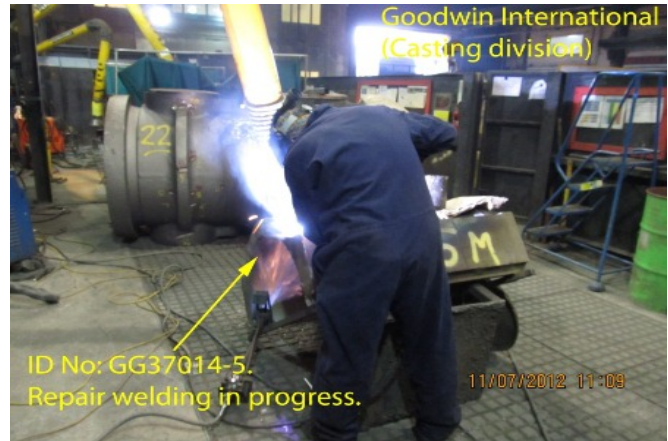
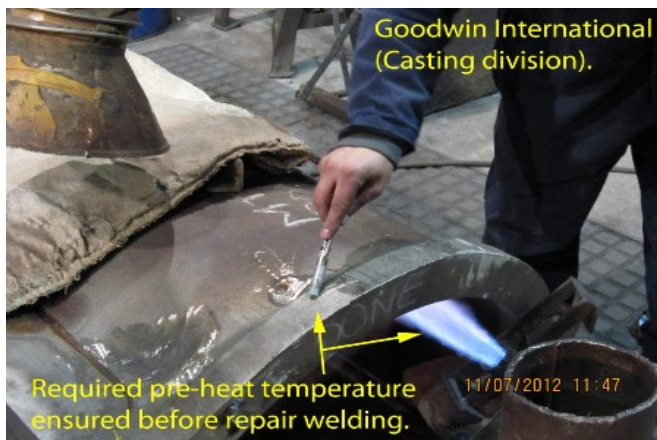
Repair welding is in progress for Clamp ID No: GG37014-5. Welder was identified as Mr. Wayne Fradley and the welding process was identified as Shielded Metal Arc Welding (SMAW). Welding was observed to be done in 1G position. Welding was done as per welding procedure specification (WPS): WPS04-0120F4A Issue-5.

Repair welding is in progress for Clamp ID No: GG37015-9. Welder was identified as Mr. James Walker and the welding process was identified as SMAW. Welding was observed to be done in 1G position. Welding was done as per WPS: WPS04-0120F4A Issue-5.

This QA Inspector observed that the pre-heating and interpass temperature was maintained as per WPS requirement; while the welding was in progress. Also proper interpass cleaning followed by interpass visual inspection was done before depositing the following run. See attached photos for details.

This QA Inspector performed random visual inspection of the completed welds and were observed free from any surface discontinuities.
